**CUT PROGRESSION DURING DYNAMOMETER
TESTING OF FOREIGN OBJECT DAMAGED TYPE
VII EXTRA HIGH PRESSURE AIRCRAFT TIRES
SAE PAPER 912155**

SEPTEMBER 1991

FINAL REPORT FOR 03/15/1984 – 06/15/1991

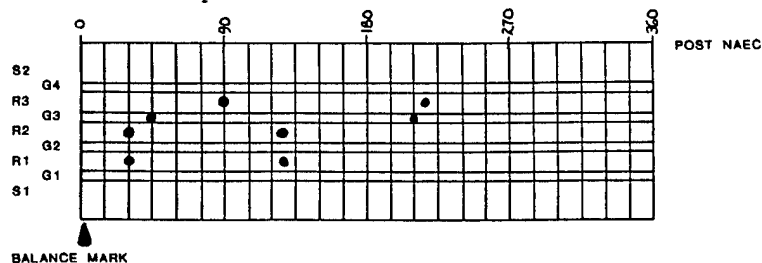
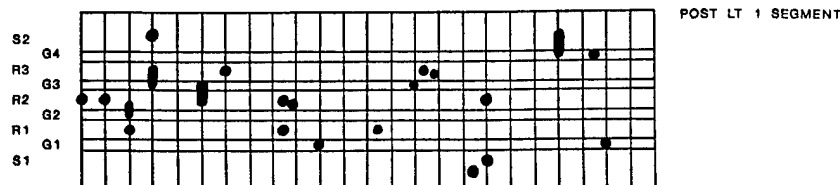
LEAST PRIMARY DAMAGE - Tire X-2A (recap) sustained the fewest primary cuts of all dynamometer tires run on the track at NAEC, and is presented in Figure 6. There were four primary cuts (with one

past the Cut Limit) and four primary blemishes. As it ran on the dynamometer, the primary damage increased, and secondary cuts and blemishes appeared. After lab segment LT 1, there were six primary cuts (two past the Cut Limit) and one primary blemish; and 12 secondary cuts (with two past the Cut Limit) and three secondary blemishes.

Only 1.9% of the impacts at NAEC resulted in primary cuts and another 1.9% resulted in primary blemishes. After LT 1, the number of all cuts equalled 8.7% of the number of impacts. The 450% increase in the number of cuts, and 275% increase in total damage were the top percentage increase of damage for all tires tested. The tire stripped 100% of the tread during TTO 2.

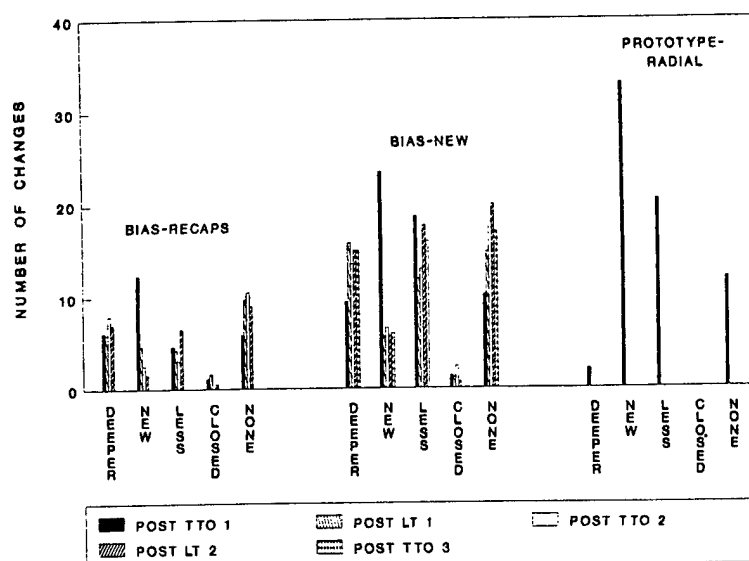
FIGURE 32: CUT ACTIVITY
during TESTING

CUT DEPTH ACTIVITY - NEW cuts are indications of secondary damage. The number of new cuts is very high after the first taxi-takeoff segment. The activity then trails off greatly. The number of cuts that closed is very small throughout the tests. As was noted with the bias ply tires, the depth of the cuts increases with more test segments on the dynamometer.
